**Flood Control Project Maintenance
Levee Inspections****LMA District Cover Sheet****Spring 2011 Levee Inspection Results****Reclamation District No. 0307 Lisbon**

Levee Inspection Report By Mile - Spring 2011

Reclamation District No. 0307 Lisbon

Waterway						Bank	Unit Miles	Inspection Start/End	Inspector	
Unit No. 01 Sacramento River						Right	6.65	03/18/2011 03/18/2011	Herman Phillips	
LMR No.	Levee Mile		Category	Item	Location	Rating	Action/Comment	GPS Latitude/Longitude		Issue No. Photo
	Start	End						Start	End	
1	0.00	0.00	Earthen Levee	Vegetation	WS	M	Control annual grass and weeds on the levee slopes and easements.	38.480099 ° -121.549404 °	38.480099 ° -121.549404 °	6 Y
2	0.00	0.00	Earthen Levee	Vegetation	LS	M	Control annual grass and weeds on the levee slopes and easements.	38.480099 ° -121.549404 °	38.480099 ° -121.549404 °	9 Y
3	0.01	0.01	Earthen Levee	Vegetation	WS	C	Remove the wild growth other than native grasses from the levee slopes.	38.480057 ° -121.549337 °	38.480057 ° -121.549337 °	23
4	1.09	1.20	Earthen Levee	Vegetation	WS	M	Remove the wild growth other than native grasses from the levee slopes.	38.472908 ° -121.532762 °	38.472922 ° -121.530695 °	94

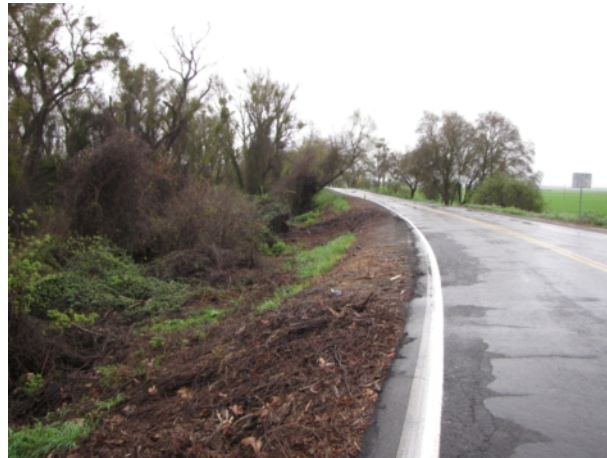
Levee Mile Report Line	1
Start Levee Mile	0.00
End Levee Mile	0.00
Location	Water Side
Category	Earthen Levee
Item	Vegetation

Photo taken of the waterside of RD 307 levee mile 0.00 looking downstream, vegetation on slopes, a private Contractor has removed a lot of this growth noted from last years's inspection. Photo taken 3-18-2011.

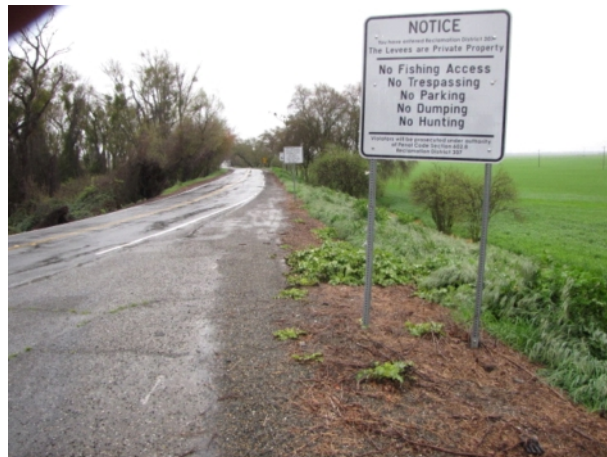
Levee Mile Report Line	2
Start Levee Mile	0.00
End Levee Mile	0.00
Location	Land Side
Category	Earthen Levee
Item	Vegetation

This photo taken here shows the land side, a private Contractor has removed a lot of the vegetation from land side. A great improvement has been made as a result of the contractor's work with the District. More work is scheduled this spring. Photo taken 3-18-2011.

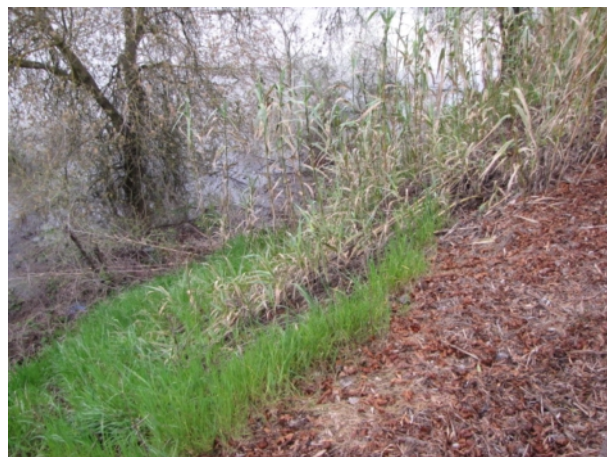
Levee Mile Report Line	11
Start Levee Mile	2.43
End Levee Mile	2.45
Location	Water Side
Category	Earthen Levee
Item	Erosion / Bank Caving

Looking downstream from waterside levee mile 2.43 at erosion on bank, you can't see the erosion very good because of the over growth of bamboo. 38.47103213 -121.5083174 photo taken 3-18-2011. This site was discovered by the land owner Mr. Borges.

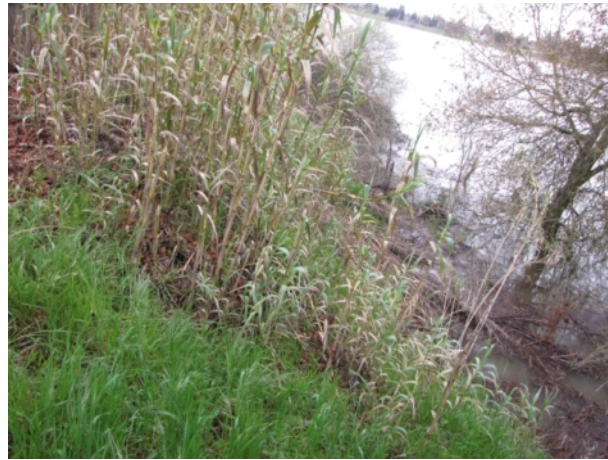
Levee Mile Report Line	11
Start Levee Mile	2.43
End Levee Mile	2.45
Location	Water Side
Category	Earthen Levee
Item	Erosion / Bank Caving

Looking back upstream from levee mile 2.45 end of the erosion, the bamboo has blocked the actual viewing of the eroded site. 38.47085468 - 121.5080261 Photo taken 3-18-2011.

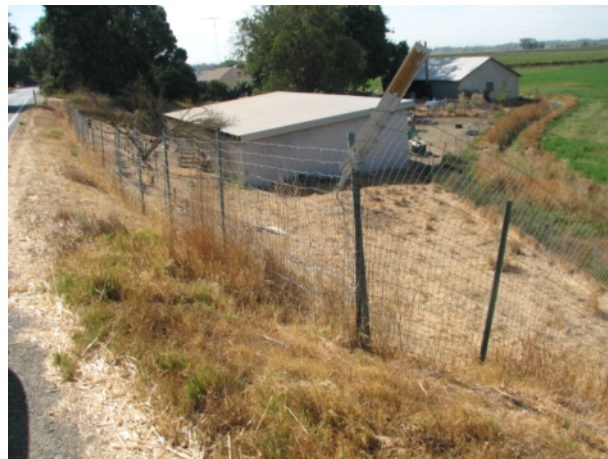
Levee Mile Report Line	14
Start Levee Mile	2.99
End Levee Mile	3.03
Location	Land Side
Category	Earthen Levee
Item	Encroachments

unauthorized fence located landward in RD 307.

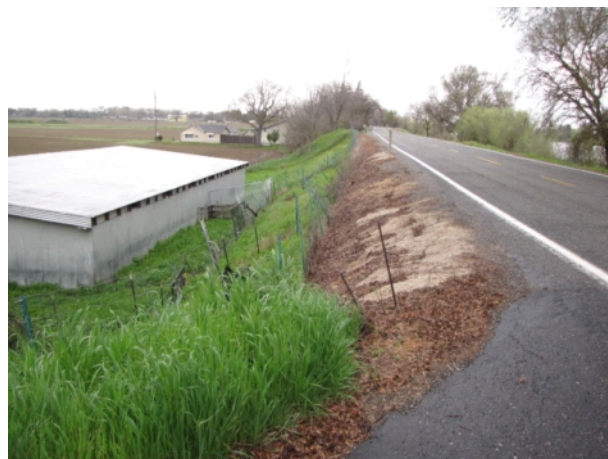
Levee Mile Report Line	14
Start Levee Mile	2.99
End Levee Mile	3.03
Location	Land Side
Category	Earthen Levee
Item	Encroachments

New photo of this unauthorized fence along the landward slope. This photo was taken 3-18-2011.

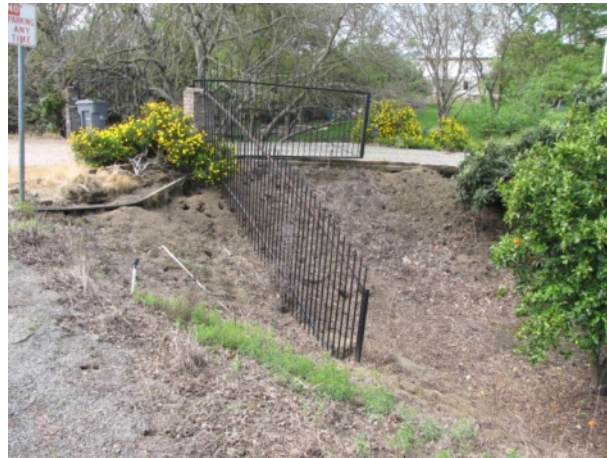
Levee Mile Report Line	17
Start Levee Mile	3.54
End Levee Mile	3.56
Location	Land Side
Category	Earthen Levee
Item	Animal Control

17	3.54	3.56	Earthen Levee	Animal Control	LS	M	Exterminate rodents and backfill and compact or grout burrows. Inspector Comments: There are counted 40-50 holes within 37-foot section of levee. Some bait need to be placed here to eradicate the rodents.	38.560402 ° -121.522426 °	38.538456 ° -121.517120 °	1 Y

This photo shows Rodent holes in slope and within ramp. There actually is a rodent in view by the iron fence just about 3-foot from the bottom of the fence line.

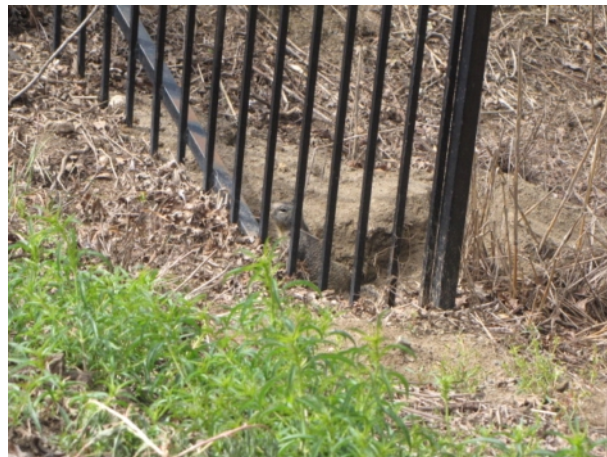
Levee Mile Report Line	17
Start Levee Mile	3.54
End Levee Mile	3.56
Location	Land Side
Category	Earthen Levee
Item	Animal Control

Photo shows live rodent near fence out side of his burrow.

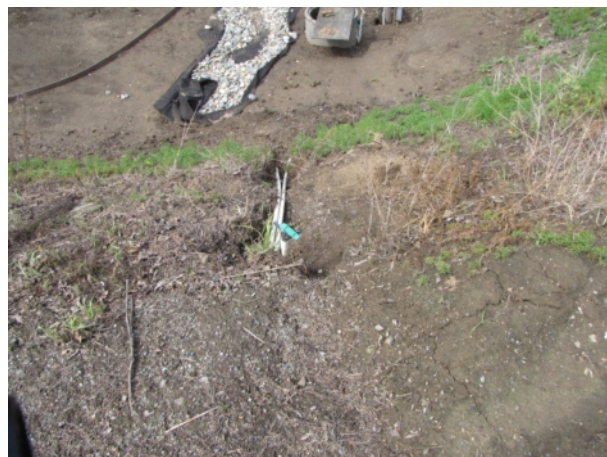
Levee Mile Report Line	18
Start Levee Mile	3.54
End Levee Mile	3.56
Location	Land Side
Category	Earthen Levee
Item	Encroachments

Photo shows pvc pipe placed in levee slope. 4 sprinklers are placed in slope.

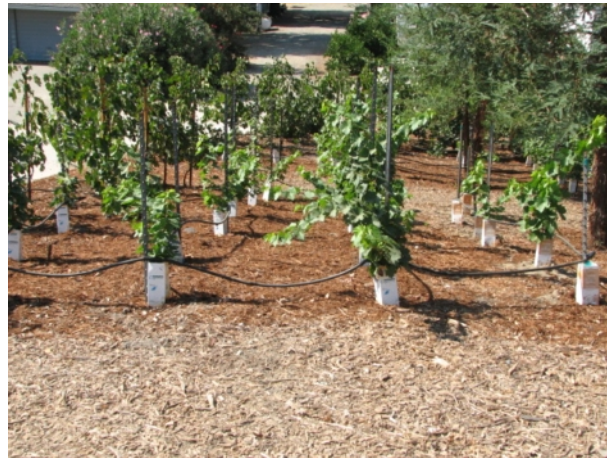
Levee Mile Report Line	32
Start Levee Mile	4.43
End Levee Mile	4.44
Location	Land Side
Category	Earthen Levee
Item	Encroachments

Unauthorized grape vines with driplines placed within levee shoulder and slope, levee miles 4.43 to 4.44 38.443798 121.50332 and 38.44365086 - 121.50322 land side. There is no Permit for this Encroachment.

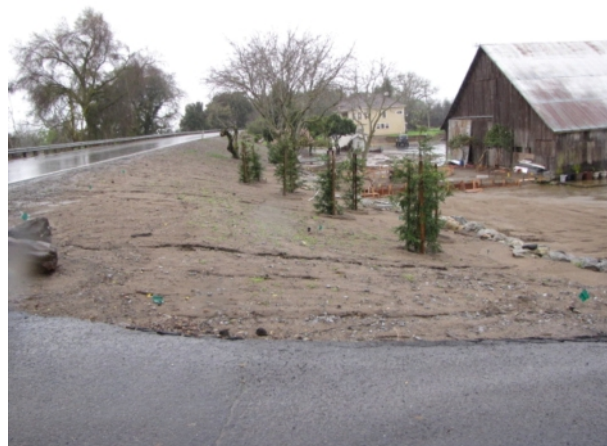
Levee Mile Report Line	35
Start Levee Mile	4.71
End Levee Mile	4.73
Location	Land Side
Category	Earthen Levee
Item	Encroachments

Looking at the unauthorized trees planted on the landward slope and toe. (6) trees planted. This photo taken 3-18-11 The encroachment is between levee mile 4.71 and 4.73.

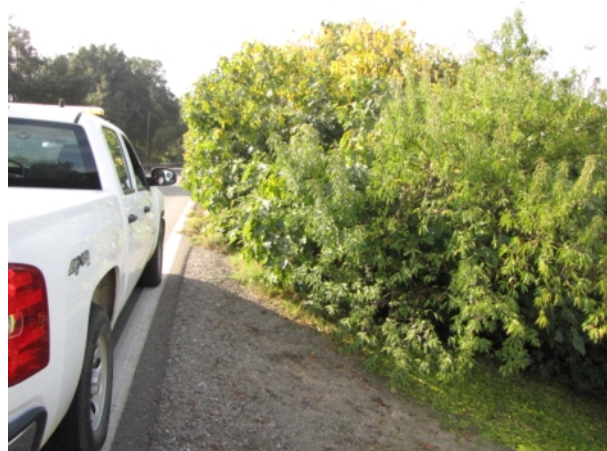
Levee Mile Report Line	37
Start Levee Mile	4.73
End Levee Mile	4.75
Location	Land Side
Category	Earthen Levee
Item	Vegetation

RD 307 landside view of unsatisfactory wild growth on levee section at levee miles 4.71 to 4.75. Photo taken 11-05-2010.

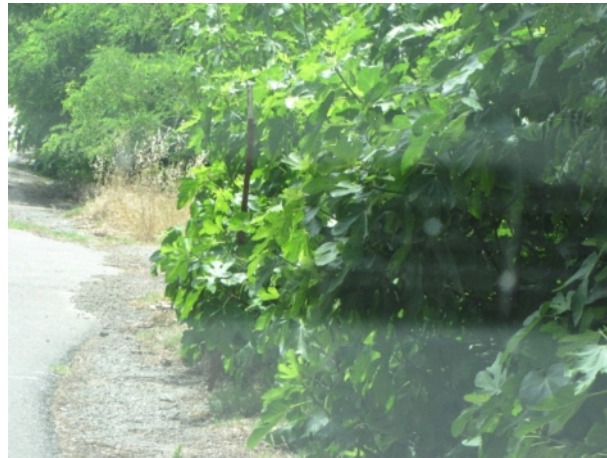
Levee Mile Report Line	38
Start Levee Mile	4.78
End Levee Mile	4.83
Location	Land Side
Category	Earthen Levee
Item	Trim / Thin Trees

Looking down stream from levee mile 4.78 the fig trees has covered the levee section on the land side. The wild growth continues down stream to 4.83. Photo taken 11-05-2010

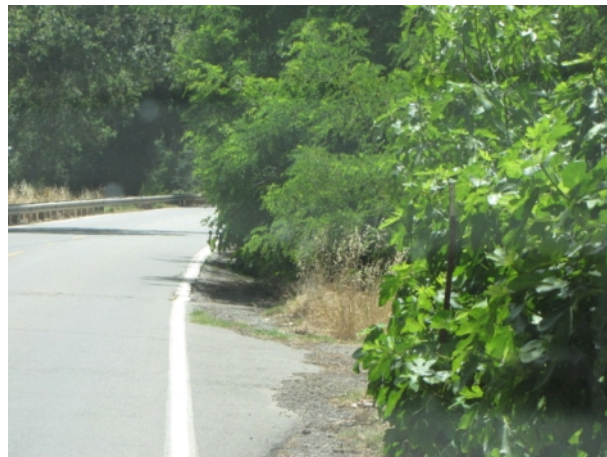
Levee Mile Report Line	38
Start Levee Mile	4.78
End Levee Mile	4.83
Location	Land Side
Category	Earthen Levee
Item	Trim / Thin Trees

Showing the wild growth continues downstream landside shoulder and slope, visibility completely blocked. Photo taken 11-05-2010

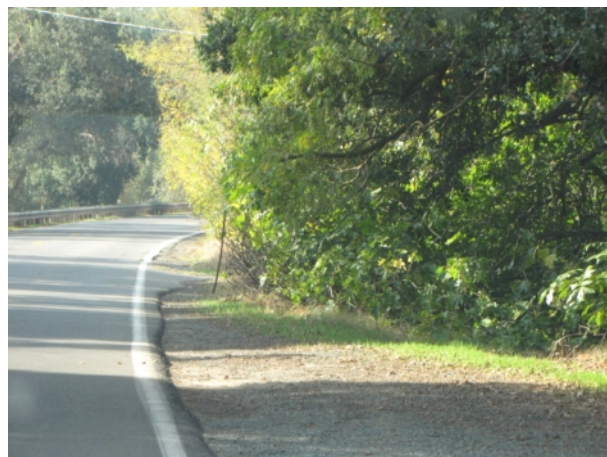
Levee Mile Report Line	39
Start Levee Mile	4.81
End Levee Mile	4.82
Location	Land Side
Category	Earthen Levee
Item	Vegetation

RD 307 levee mile 4.81 unsatisfactory growth on landside levee shoulder and slope. Photo taken 11-05-2010

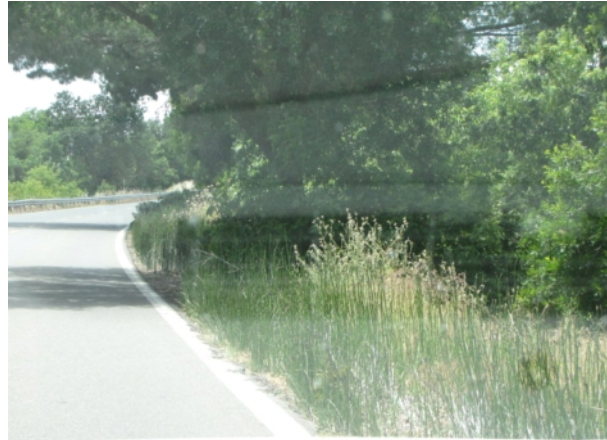
Levee Mile Report Line	45
Start Levee Mile	5.16
End Levee Mile	5.20
Location	Water Side
Category	Earthen Levee
Item	Vegetation

Wild growth on landside at leve mile 5.16 to 5.20 looking down stream.

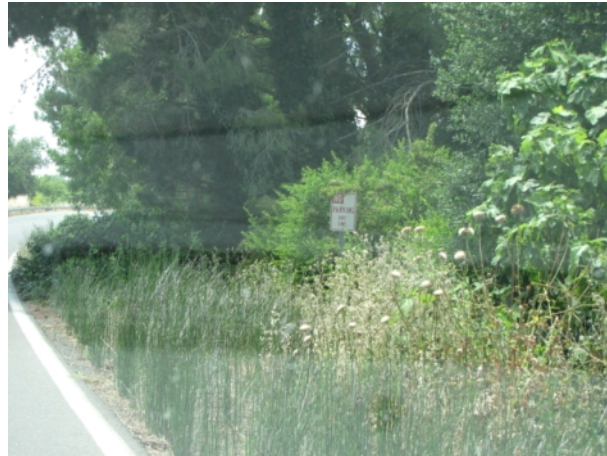
Levee Mile Report Line	45
Start Levee Mile	5.16
End Levee Mile	5.20
Location	Water Side
Category	Earthen Levee
Item	Vegetation

Looking downstream levee mile 5.16-5.20.
